FINAL REPORT OF SPECIFIC PURPOSE LIDAR SURVEY

LiDAR, Breaklines and Contours for Jefferson County, Florida

State of Florida
Division of Emergency Management
Contract 07-HS-34-14-00-22-469
Task Order 20070525-492718a
PDS Task Order B

October 30, 2009

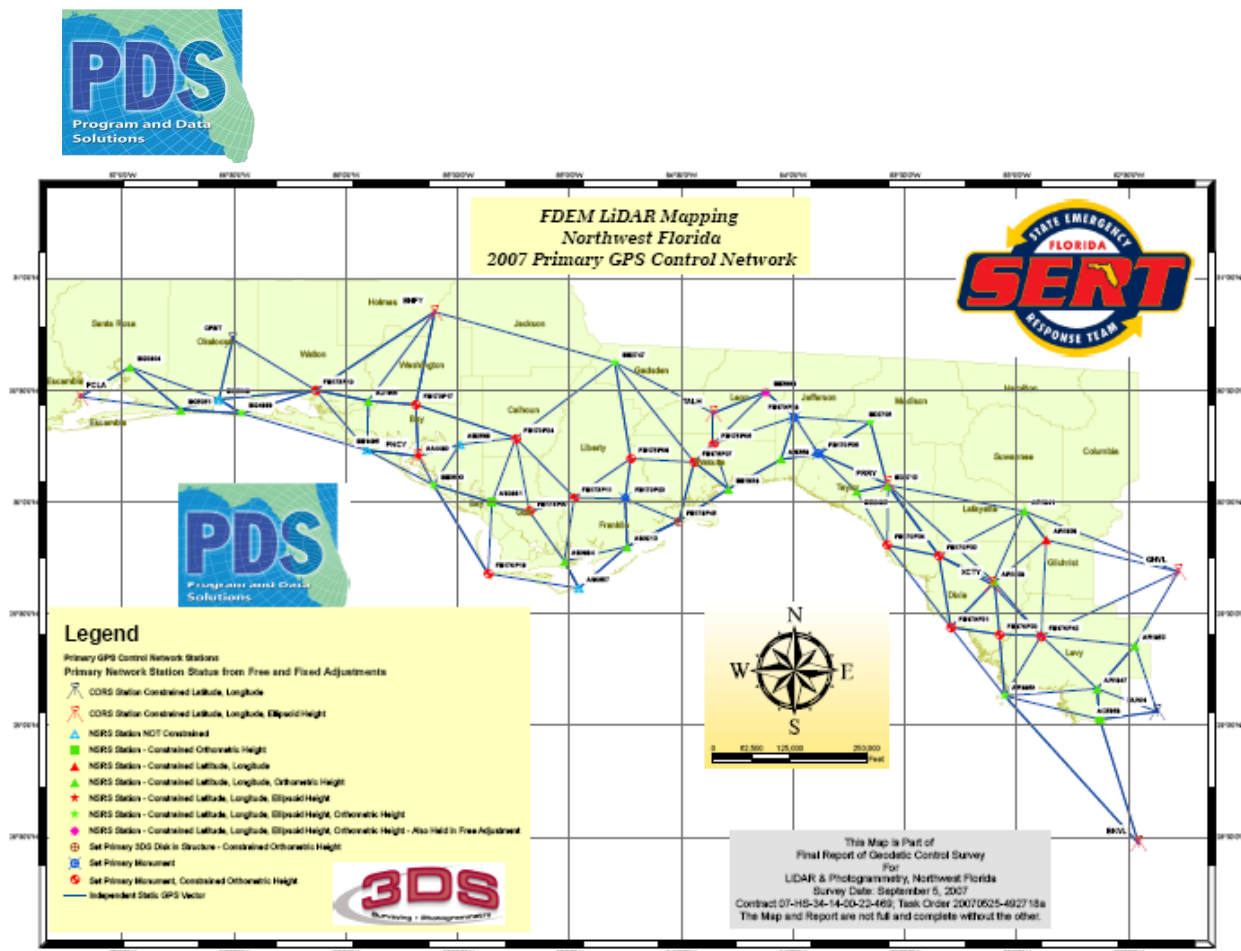
Figure 1. Primary Control Network

The Primary network stations (see Figure 1) were used as base stations supporting the airborne GPS data acquisition, and as a consistent control framework for the more densely spaced Secondary control networks, and all subsequent control surveying activity on the project. They were setup at 40 kilometer spacing per the 2 centimeter requirements for Primary Control stated in the NOS NGS-58. The Primary Control network consisted of 55 stations, including 10 Continuously Operating Reference Stations (CORS), 27 existing monuments from the National Spatial Reference System (NSRS) and 18 new monuments set so as to limit LiDAR GPS baseline lengths to 20 Km relative to GPS base stations on either side of stations spaced ≈ 40 Km apart. Third order differential leveling was used to establish elevations on 20 Primary network stations in specific areas where published vertical stations could not be occupied directly with GPS. A minimally constrained (free) Least Squares adjustment was run to verify the internal accuracy of the Primary network. After evaluating and removing any outliers, a final free adjustment was generated, consisting of 191 independent vectors. The input error estimates were scaled by a factor of 14.90 which resulted in a properly weighted adjustment with a variance factor of 1.0154, with no flagged residuals. A constrained (fixed) 3-D horizontal adjustment was run using the same input error estimates as were used in the free adjustment; the variance factor was 1.3712 and there were no flagged residuals. A constrained (fixed) 1-D vertical adjustment was run using the same input error estimates as were used in the free adjustment; Station BE3991 was fixed in latitude, longitude and orthometric height; the variance factor was 1.2866 and there were no flagged residuals.

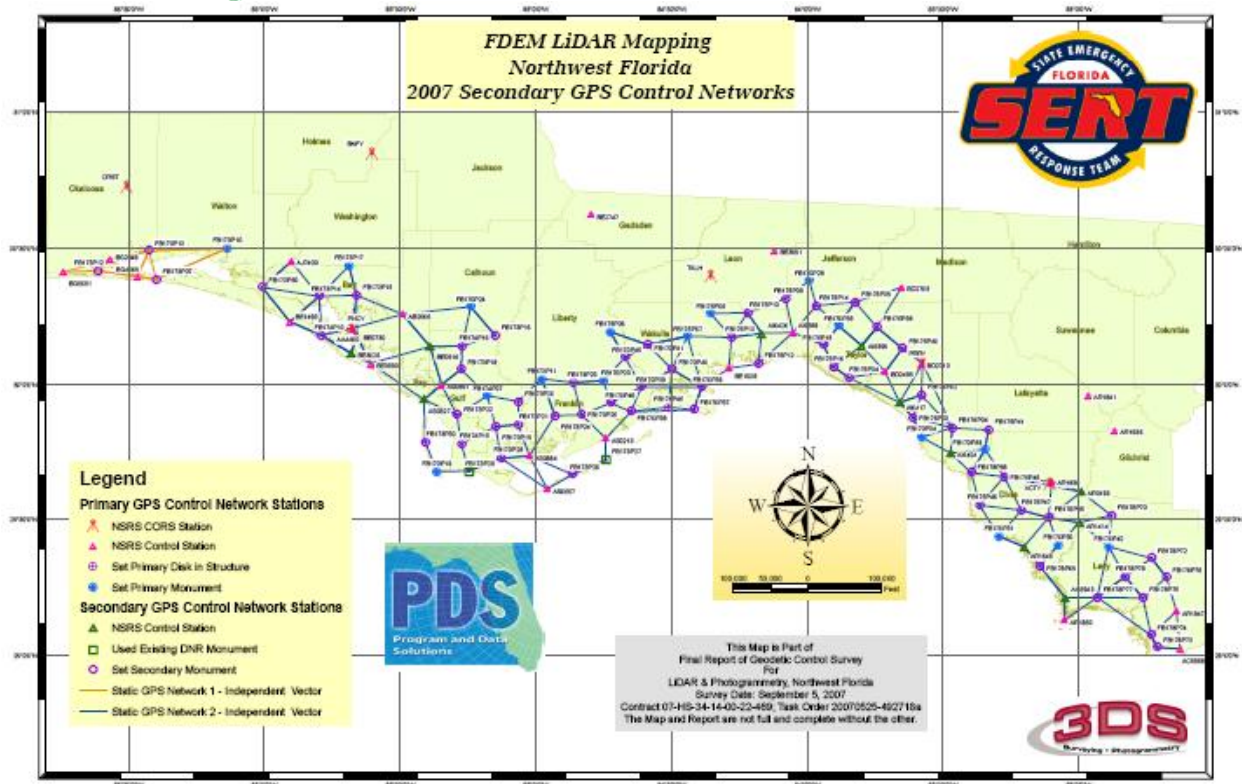
Figure 2. Secondary Control Networks

The first Secondary Control network consisted of 4 stations in the Okaloosa County area. The second Secondary Control network consisted of all remaining mapping areas in the Florida Panhandle. The Secondary Control networks included a total of 80 control points, including 16 recovered NSRS monuments, 2 recovered DNR monuments, and 62 new monuments set for this network. A minimally constrained (free) Least Squares adjustment was run to verify the internal accuracy of the Secondary networks. After evaluating and removing any outliers, a final free adjustment was generated. This final free adjustment consisted of 254 independent vectors. The input error estimates were scaled by a factor of 6.234, which resulted in a properly weighted adjustment with a variance factor of 1.000; there were no flagged residuals. A constrained (fixed) 3-D horizontal adjustment was run using the same input error estimates as were used in the free adjustment; the variance factor was 1.6339 and there were six flagged residuals. A constrained (fixed) 1-D vertical adjustment was run using the same input error estimates as were used in the free adjustment; Station BE3991 was fixed in latitude, longitude and orthometric height; the variance factor was 1.2136 and there were no flagged residuals.

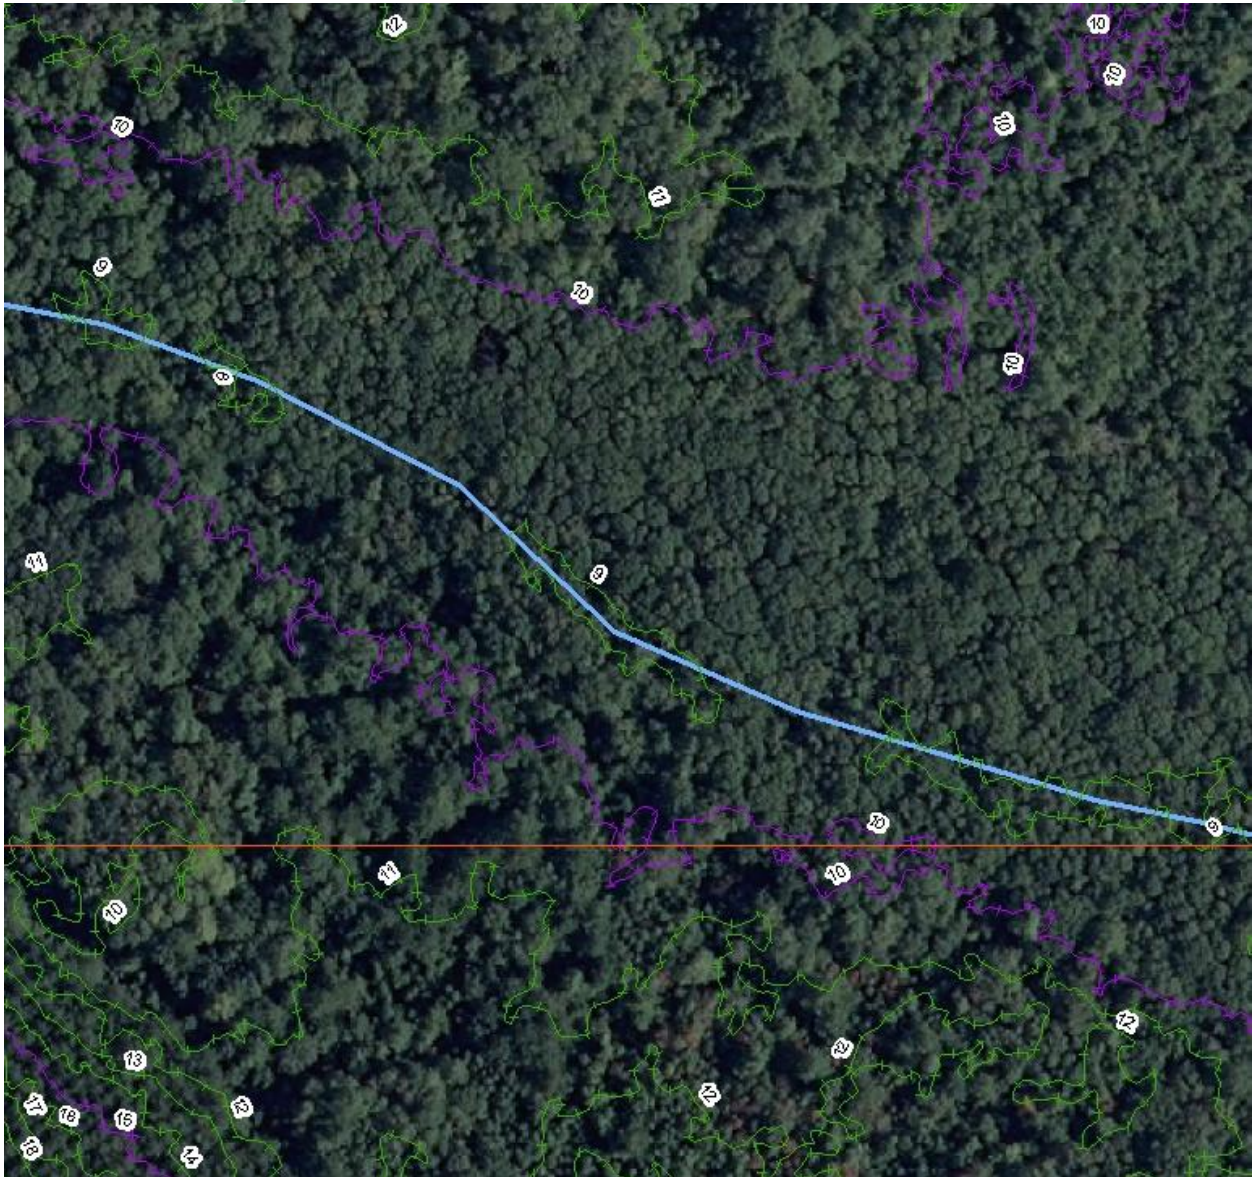
Figure 3. Even in very dense vegetation, the PDS team's high LiDAR point density (4 points per square meter) enabled the detection of dry drainage features beneath the vegetation.

The five figures below demonstrate how the PDS team’s high LiDAR point density (4 points per square meter) are used to penetrate dense vegetation and accurately map the dry drainage feature not visible from a normal digital orthophoto (Figure 1); the total density of the LiDAR point cloud (Figure 2); the density of LAS Class 2 points that penetrated to the ground (Figure 3); the color-coded Terrain to help in visualizing the variable elevations (Figure 4); and the soft hydro breakline that approximates the potential flow line of the dry drainage feature and the contours that clearly show the undulations in the Terrain (Figure 5). At Figure 5, the 9-foot contour lines are *depression contours* that surround elevation points that are lower than 9-feet. Although the undulations, by definition, are not “hydro-enforced,” the PDS Team’s PSM in responsible charge of this project considers it a violation of professional standards if one were to deliberately degrade the accurate Terrain, soft hydro breakline and contours in a dry drainage feature in order to “hydro-enforce” that feature by filling the depressions and falsely scalping off the higher undulations in order to make an idealized monotonic dry streambed out of the true undulating streambed. To “hydro-enforce” such a dry streambed would be to falsify the true topography of naturally undulating terrain. The soft hydro breaklines are part of the hydrographic feature class, but have a separate sub-class code, 3. This enables hydro-enforced hydrographic features, sub-class codes 1 and 2 for single and dual lines, to be distinguished from these non-hydro-enforced soft hydrographic features representing dry drainage features.

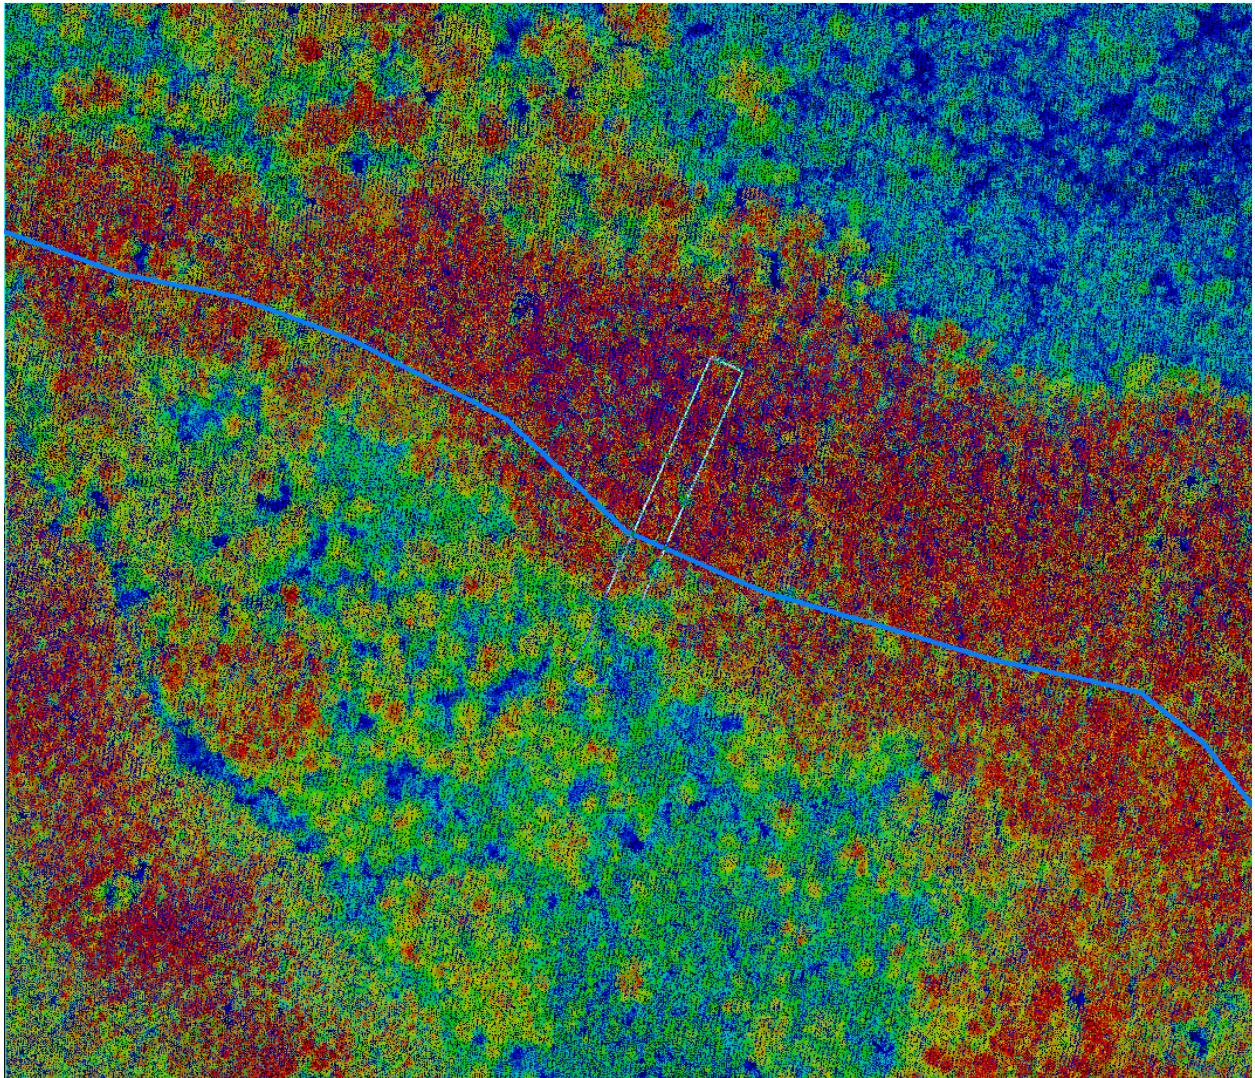
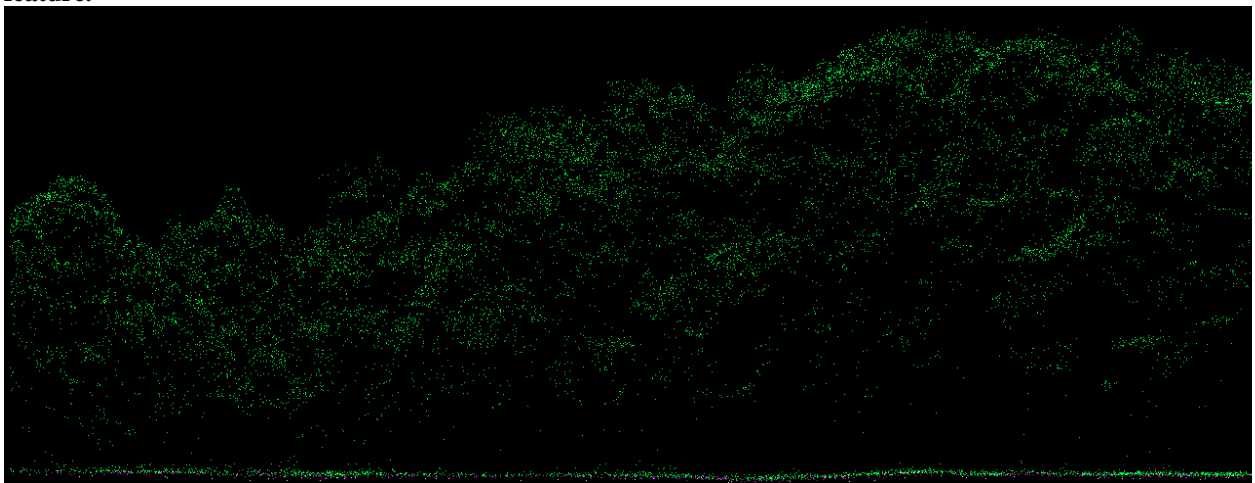
Figure 4. Full point cloud with profile (below) showing density of vegetation in the area of the dry drainage feature.

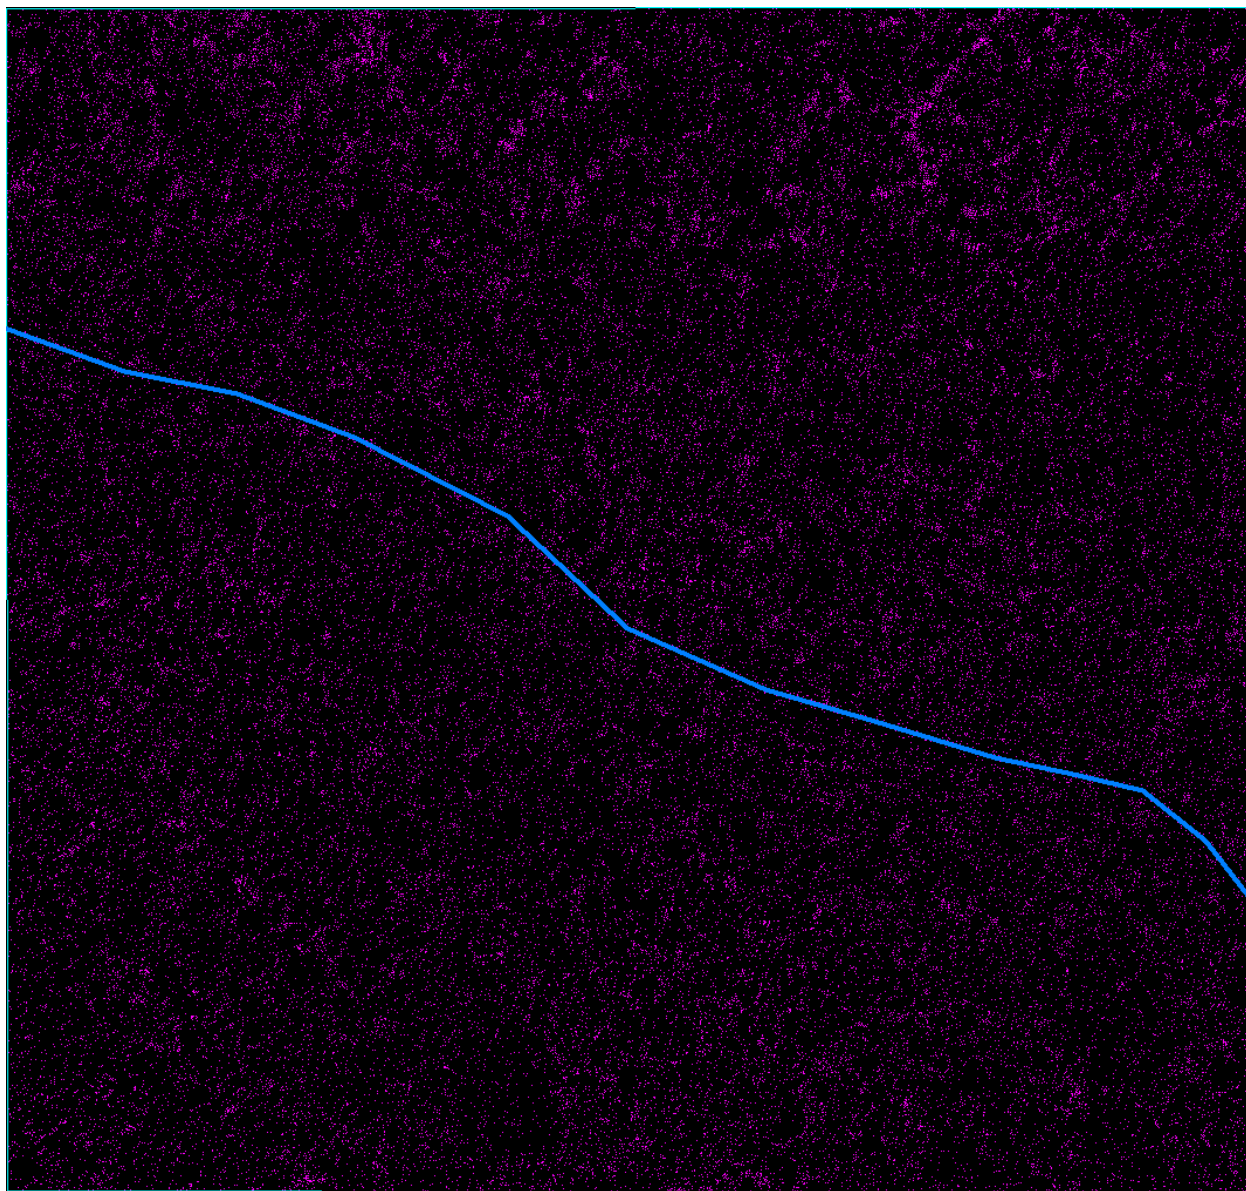
Figure 5. LAS Class 2 (ground) points showing the high density of points that penetrated the vegetation.

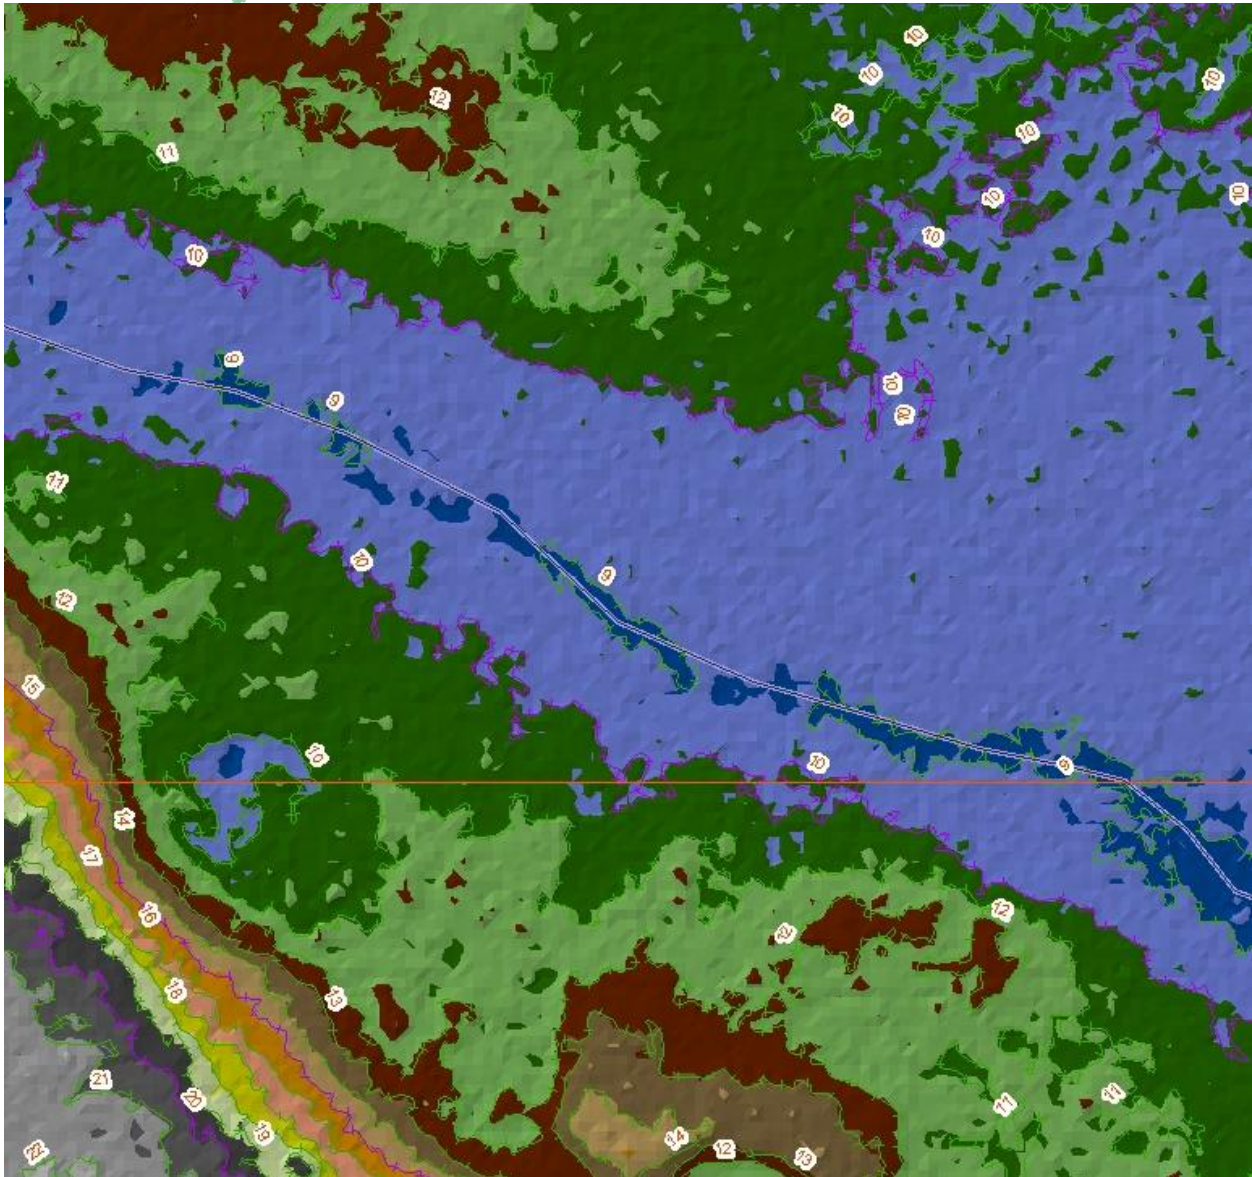
Figure 6. The ESRI Terrain is color-coded to depict the variable elevation bands. This clearly shows the lower, undulating elevations in the dry drainage feature.

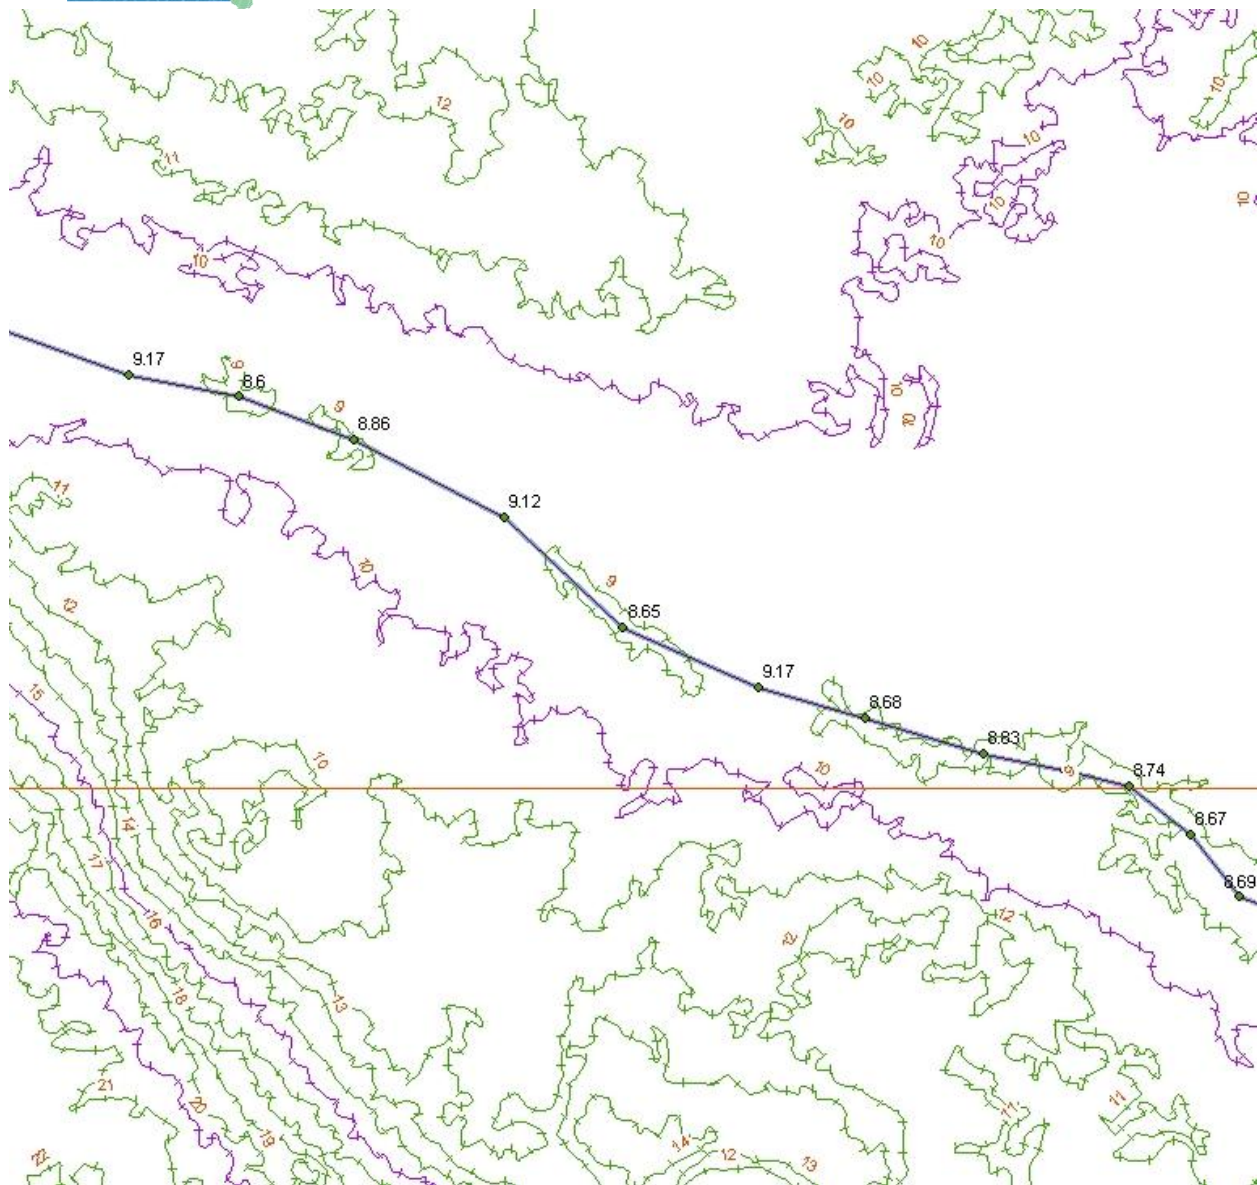
Figure 7. This figure shows variable “invert elevations” along the soft hydro breakline. It also shows “depression contours” where water would normally puddle if the drainage feature was only half dry. The soft hydro breakline passing through the “depression contours” clearly depict elevations lower than the 9-foot contour lines.

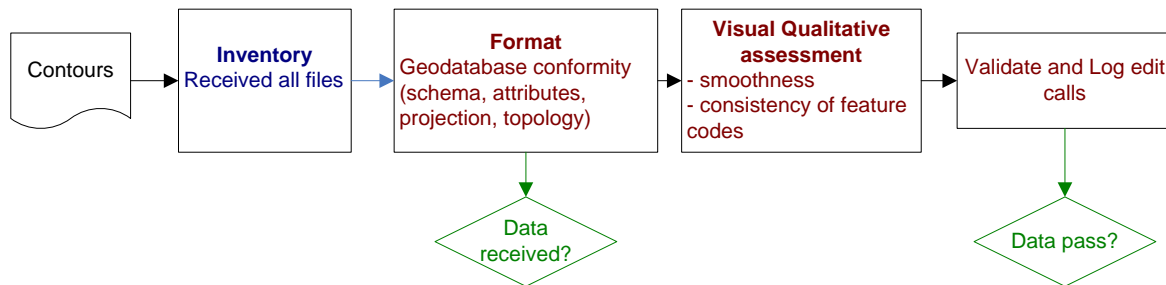
Dewberry also performed the qualitative assessments of the contours using the following workflow.

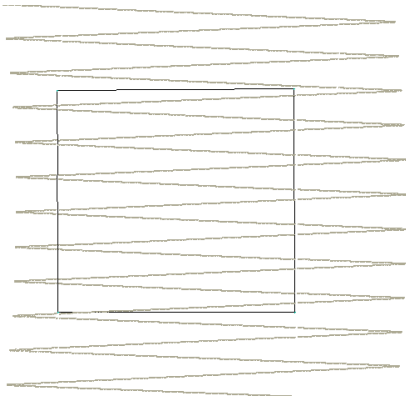
Figure 2: Calibration Pass 1

Additionally, a pass is made in profile mode across the middle of the building to compensate for any bias in pitch.

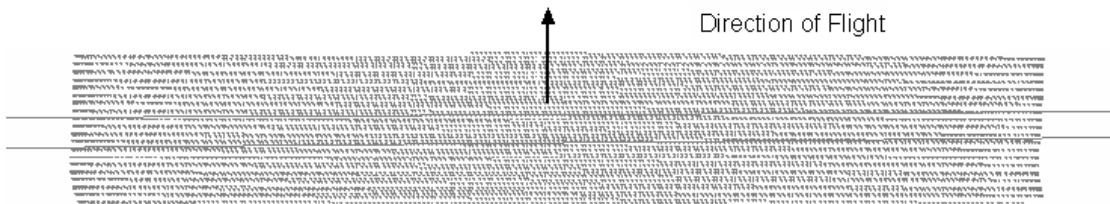
Figure 4: Runway Calibration

Approximately 25,000 LiDAR points are observed with each pass. A Triangulated Irregular Network (TIN) surface is created from these passes. The ground control x,y,z points are then compared with the z of the LiDAR surface to compute vertical residuals of the LiDAR data. After careful analysis of noise associated with non-runway returns, any system bias is documented and removed from the process.

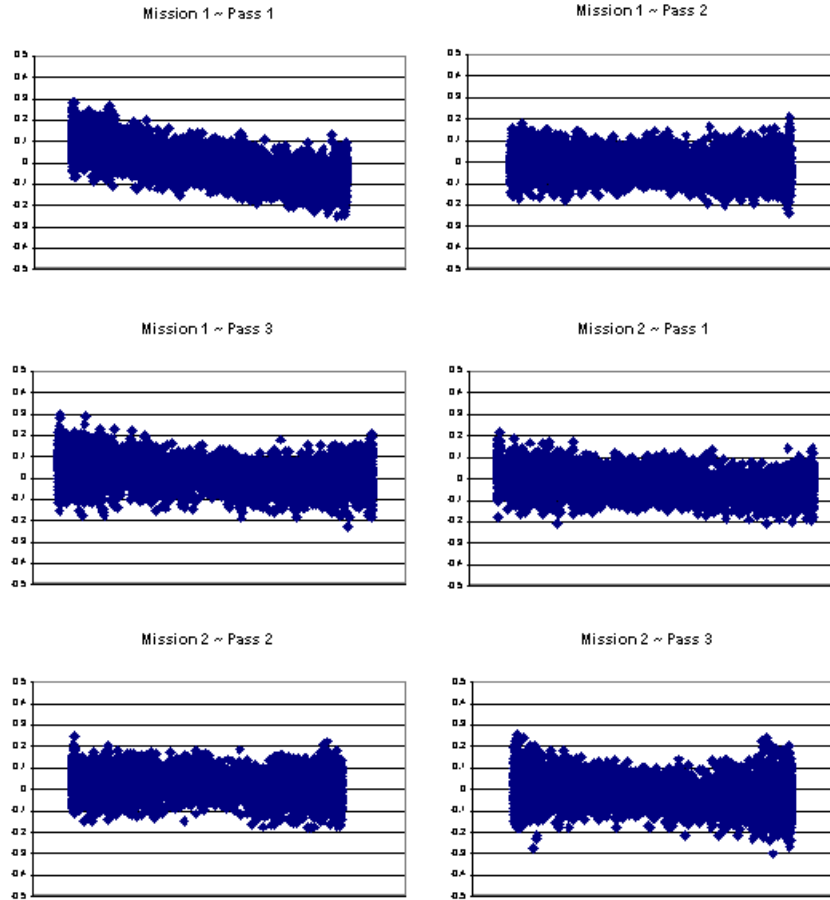
Figure 5: Runway Calibration Results

The calibration is done based on a kinematic survey on the runway. Given that the Kinematic survey RMSE is no better than 4 centimeters as a result of none exact height of the antenna and weight of the aircraft. Sanborn was required to do additional check points in the project area to meet the 9.25 centimeter vertical accuracy requirement knowing that the calibration site is only good to 4 centimeters RMSE. A z bump adjustment was made to the entire data set based on the survey points in the project area and the relative accuracy of the data to itself and in all areas.

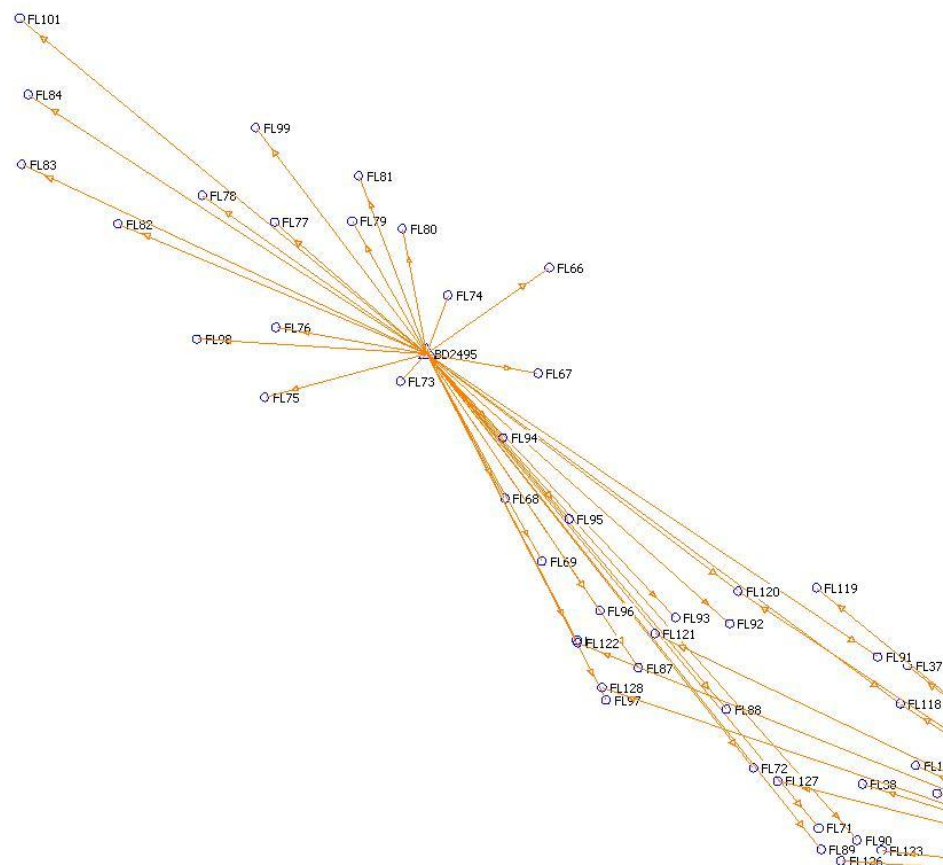
Figure 6: FDEM Survey Checkpoint Diagram

The LiDAR data was evaluated using a collection of 60 GPS surveyed checkpoints. 20 points were collected in each bare earth, low grass, and urban vegetation classes, see Figure 6 for diagram. Three of these checkpoints fell within Jefferson County.

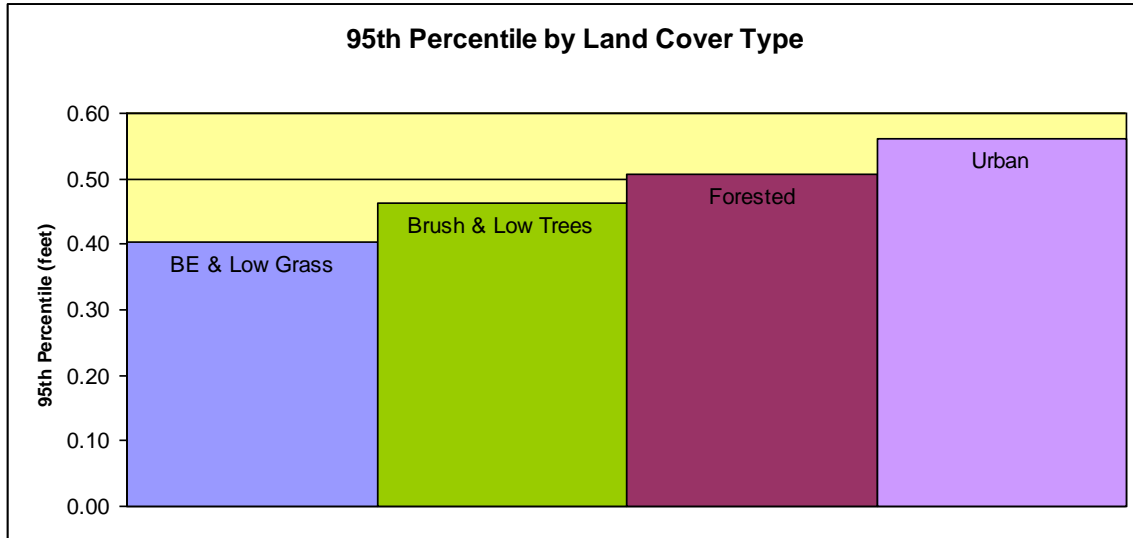
Figure 2 — Graph of SVA Values by Land Cover

Figure 2 illustrates the SVA by specific land cover category.

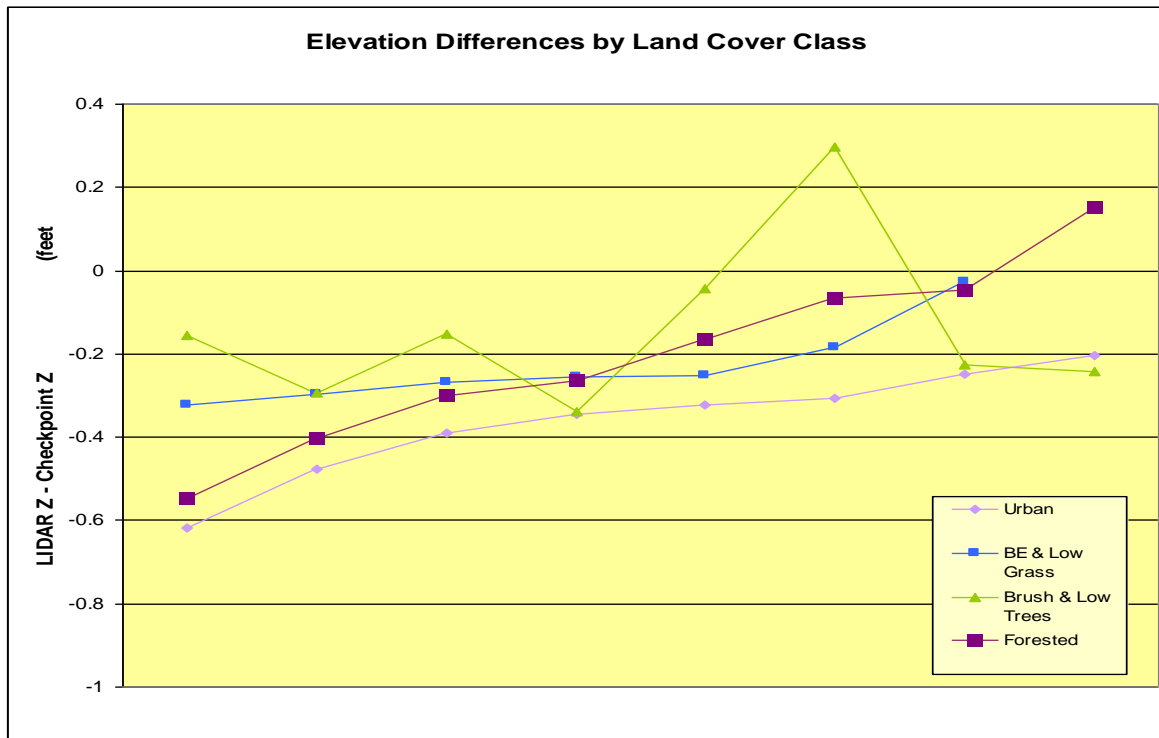
Figure 3 illustrates the magnitude of the differences between the QA/QC checkpoints and LiDAR data by specific land cover category and sorted from lowest to highest. All land cover classifications indicate a slight negative skew, but meet the accuracy specifications.

Figure 3 – Magnitude of Elevation Discrepancies, Sorted from Largest Negative to Largest Positive Vertical Accuracy Testing in Accordance with NSSDA and FEMA Procedures

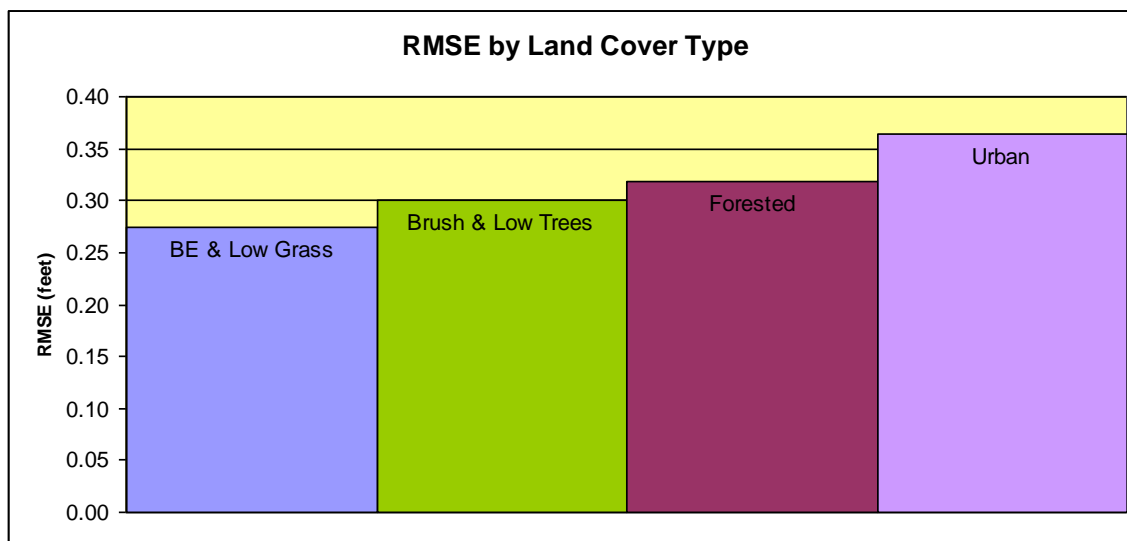
Figure 4 — $RMSE_z$ statistics by Land Cover Category

The NSSDA and FEMA guidelines were both published before it was recognized that LiDAR errors do not always follow a normal error distribution. Future changes to these FGDC and FEMA documents are expected to follow the lead of the NDEP and ASPRS. Nevertheless, to comply with FEMA’s current guidelines in Reference C, $RMSE_z$ statistics were computed in all four land cover categories, individually and combined, as well as other statistics that FEMA recommends to help identify any unusual characteristics in the LiDAR data. These statistics are summarized in Figures 4 and 5 and Table 4 below, consistent with Section A.8.6.3 of Reference C.

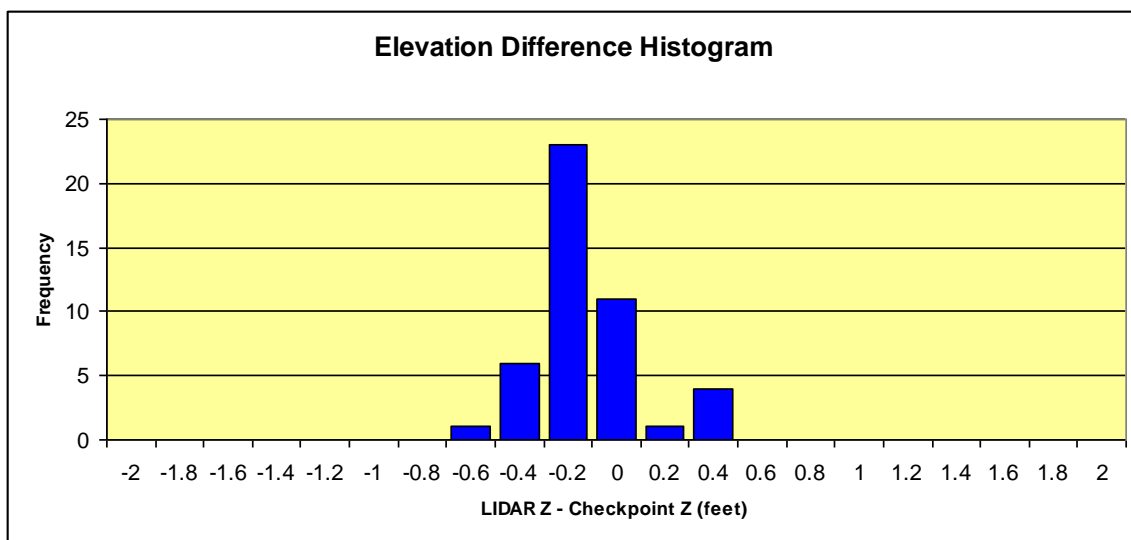
Figure 5 illustrates a histogram of the associated elevation discrepancies between the QA/QC checkpoints and elevations interpolated from the LiDAR triangulated irregular network (TIN). The frequency shows the number of discrepancies within each band of elevation differences. Although the discrepancies vary between a low of -0.62 ft and a high of +0.38 ft, the histogram shows that the majority of the discrepancies are skewed on the negative side of what would be a “bell curve,” with mean of zero, if the data were truly normally distributed. Typically the discrepancies tend to skew a bit more to the positive side, because discrepancies in vegetation are typically positive. The negative skew difference in this case, though minor, may indicate a slight systematic error. We saw no cause for concern, based on the fact that there are relatively few tiles in this county and that the checkpoints easily passed the vertical accuracy criterion.

Figure 5 — Histogram of Elevation Discrepancies within 0.10 m Bands

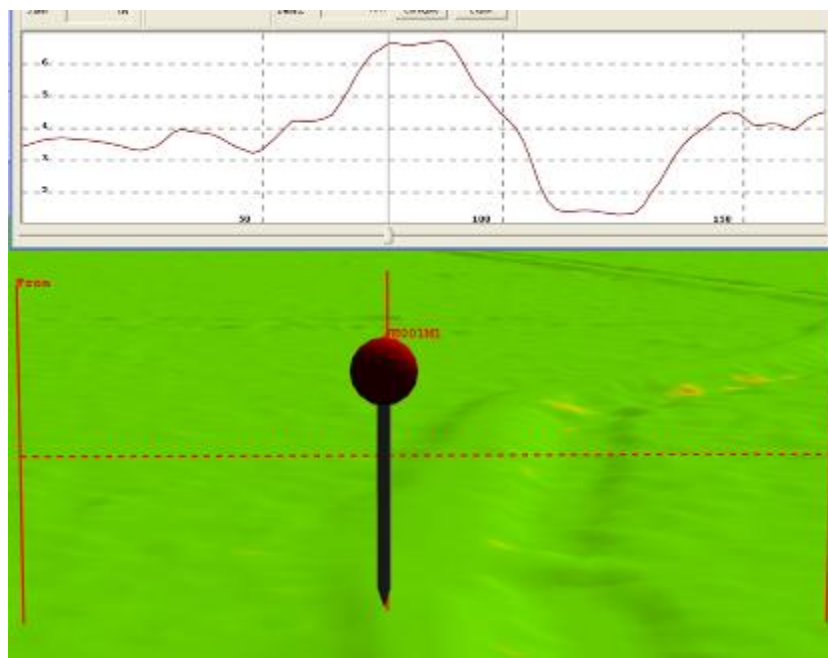
Figure 7 — Checkpoint JE001M1 Bare-earth and Profile

Figure 7 shows checkpoint JE008M6 (green point) on the bare-earth surface with profile line and the inset shows the profile slope. The vertical graduation is at 1.0' intervals and the horizontal graduations are at 50.0' intervals.

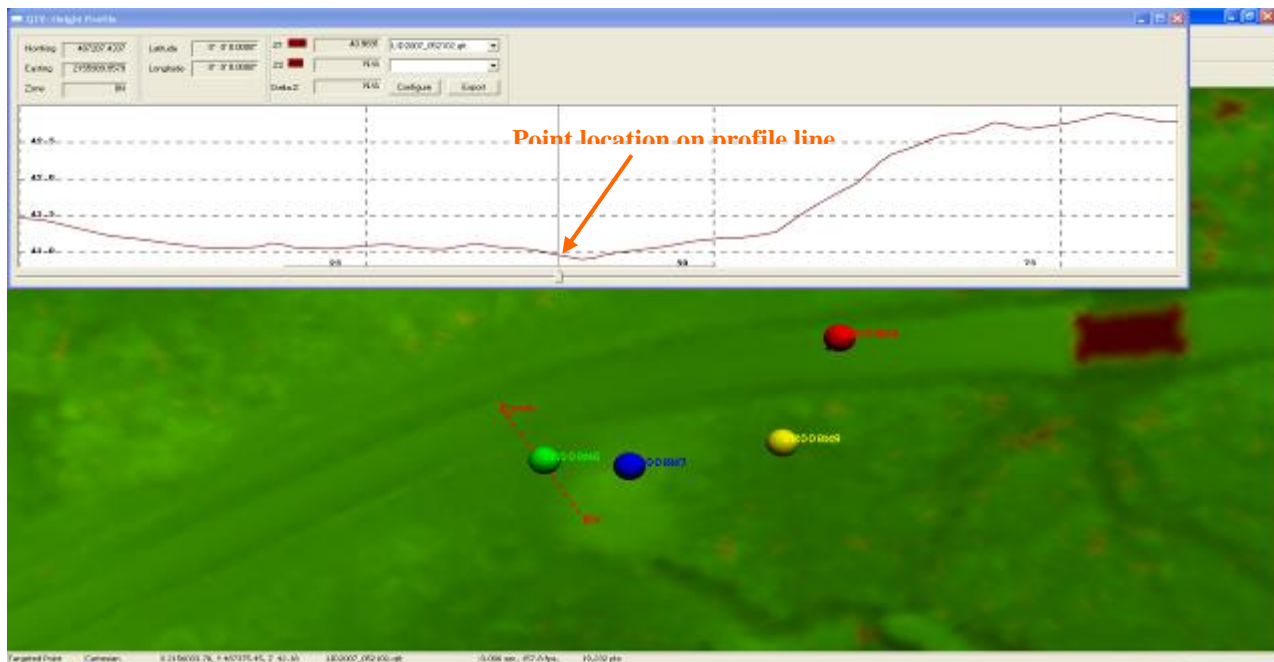
Figure 9 — Checkpoint JE008M6 bare-earth and profile

Figure 9 shows checkpoint JE008M6 (green point) on the bare-earth surface with profile line and the inset shows the profile slope. The vertical graduation is at 0.5' intervals and the horizontal graduations are at 25.0' intervals.

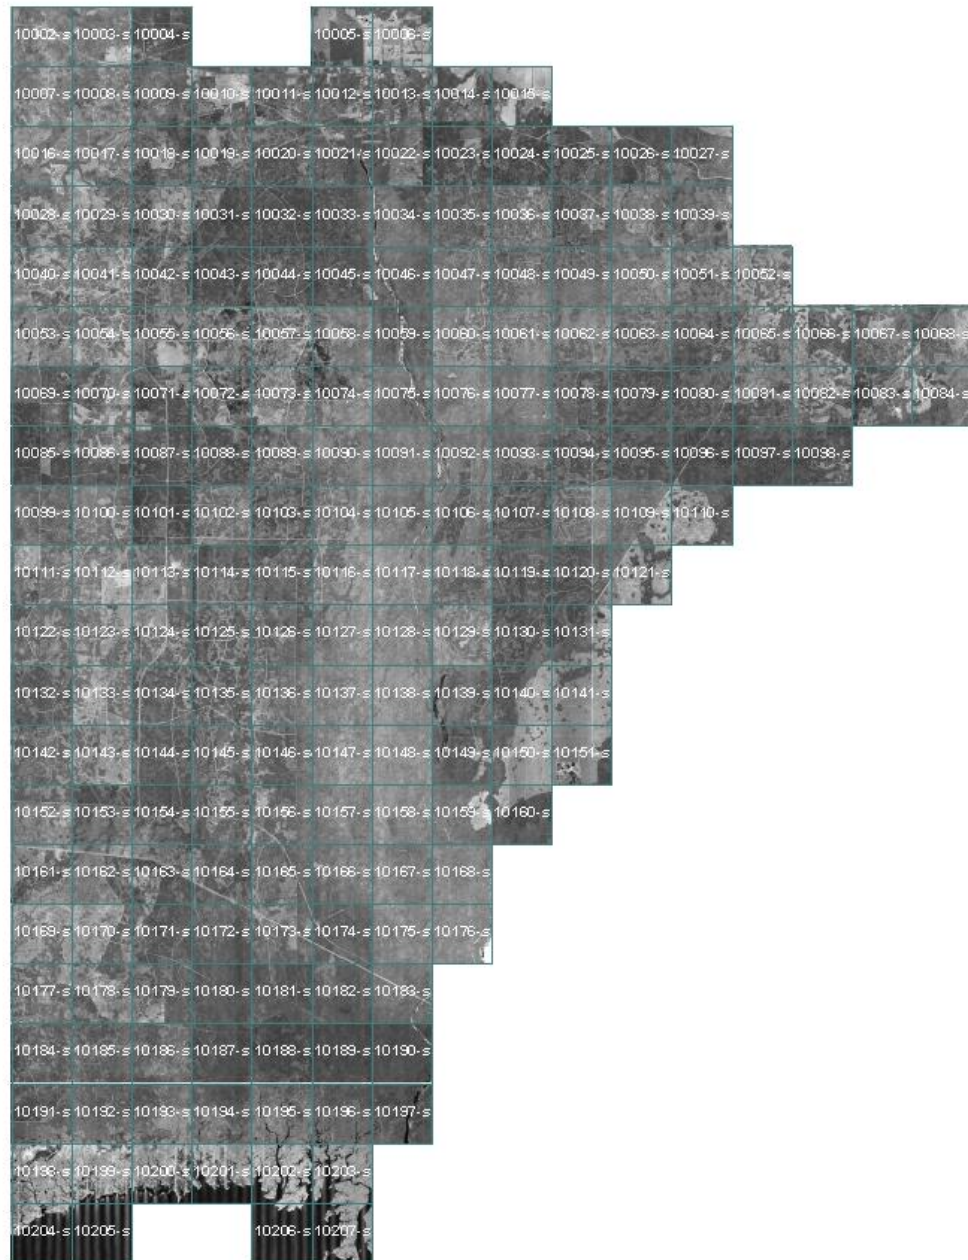
3. *Data Void/ Gap Checks*-The imported .LAS files were used to create LiDAR “orthos”. The LiDAR orthos were one of the tools used to verify data coverage and point density, to check for data voids or gaps, and to use as reference data during checks for data anomalies and artifacts. This product is not intended to be a project deliverable. The orthos were derived from the Full Point Cloud elevations and LiDAR pulse return intensity values. The intensity values were used as delivered with no normalization applied. Due to the point density of the Florida Baseline Specifications, the orthos were produced at a 1.2m pixel for the entire area of interest (see Figure 1).

Figure 9 Jefferson County LiDAR Orthos produced from Intensity Returns

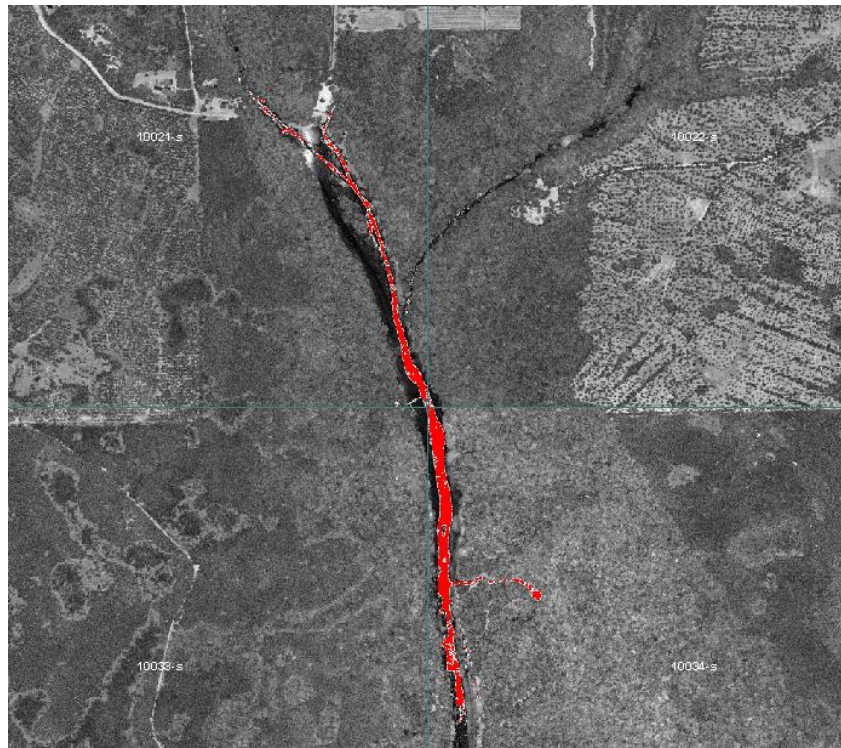
Voids (areas with no LiDAR returns in the LAS files) that are present in the majority of LiDAR projects include voids caused by bodies of water. These are considered to be acceptable voids (Figure 2).

Figure 10 Acceptable voids in data due to water bodies

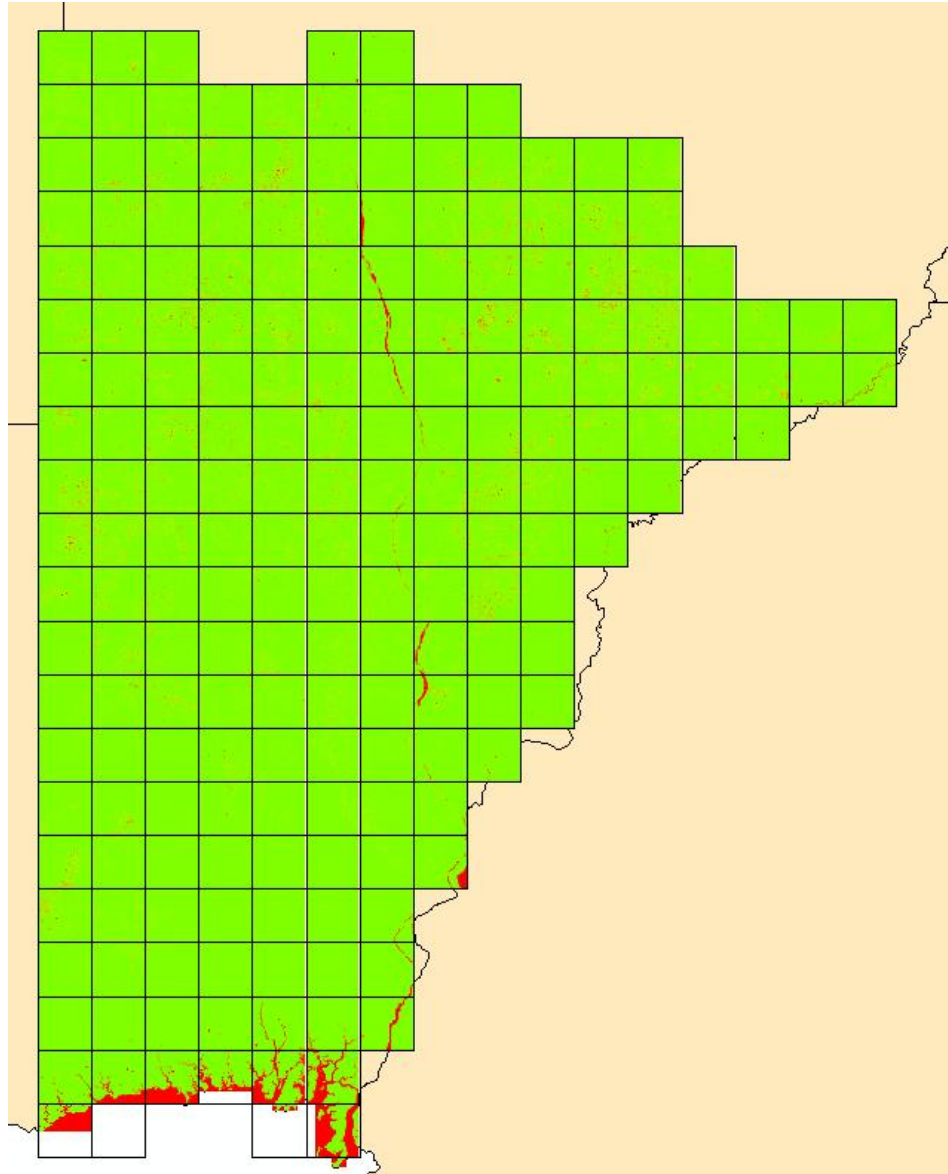
Model statistics were produced and characterized by density, scale, intensity, and elevation. (Figure 5) The low confidence area polygons were overlaid onto the density grids to ensure that all low confidence areas were properly identified with a polygon. As with the LiDAR orthos, this product was produced for Quality Assessment purposes only.

Figure 11 Density grid of Jefferson County, created using a green to red color ramp. Green areas meet project specifications; red delineates areas not meeting minimum density requirements (primarily water and low-confidence areas)
